INCIDENT ALERT

LOCATION: ^[1]	Company-wide	ALERT STATUS:	Normal
ACTIVITY: ^[2]	Maintenance and housekeeping	DATE ISSUED:	21/04/2016
SUB ACTIVITY:	n/a	INCIDENT No:	01428

Equipment mounted at height

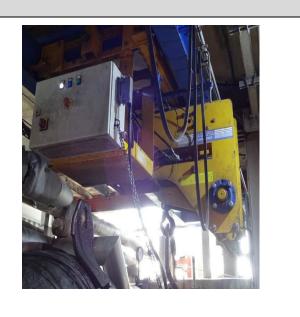
- Secondary securing devices prevent a component falling from height if the primary securing method fails. This could be a safety wire or some other engineered method designed for this function. Secondary securing devices should be sufficient to withstand the shock loading that may occur if the primary securing method fails.
