# INCIDENT ALERT

Collapse of Standing Trailer

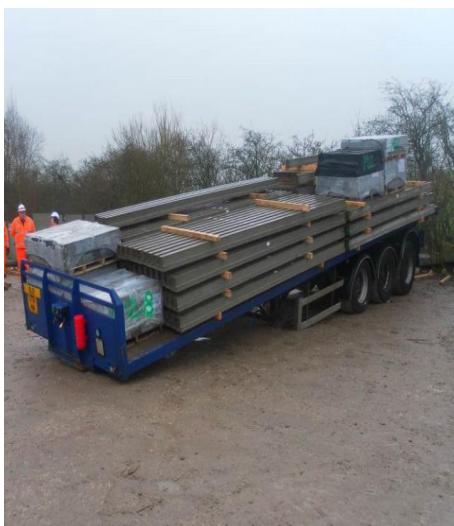
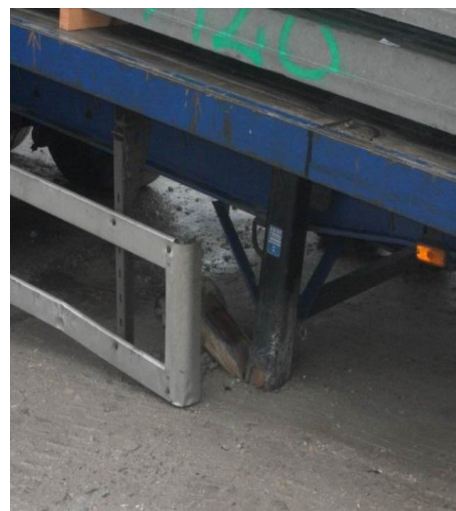
## ACCIDENT / INCIDENT - IMAGES

A Contractor had just completed the loading of a pre-stressed beam and block consignment onto a 40ft third party haulier's standing trailer when the supporting legs gave way resulting in the partial collapse.

On this occasion the load remained intact and therefore the impact was damage only, but the potential was far greater.

Investigations identified that the weight of the load was appropriate for the trailer. However, the sequence of loading had placed excessive force onto the standing legs for a prolonged period of time, without a counter force / weight being applied to the axle area of the trailer bed. This caused the standing legs to fail.

- Review task risk assessments, ensuring all circumstances that could result in a vehicle / trailer collapse are identified and that appropriate control measures are implemented to prevent such an event
- Ensure all personnel responsible for loading are aware of the requirements of appropriate load distribution
- Ensure all loading and standing areas are appropriate (good, firm and level ground)
- Avoid leaving loaded trailers standing for prolonged periods of time
- Ensure vehicles and trailers are subjected to frequent and appropriate inspection by competent persons
- Formulate task specific SWP ensuring all loading operators are briefed/trained via toolbox talks accordingly and understand the safe systems of work. Maintain appropriate records
