# INCIDENT ALERT

<b>LOCATION:</b> <sup>[1]</sup>	Concrete Products	<b>ALERT STATUS:</b>	Normal
<b>ACTIVITY:</b> <sup>[2]</sup>	Lifting	<b>DATE ISSUED:</b>	27/04/2016
<b>SUB ACTIVITY:</b>	n/a	<b>INCIDENT No:</b>	01429

Catastrophic Failure of Clamp

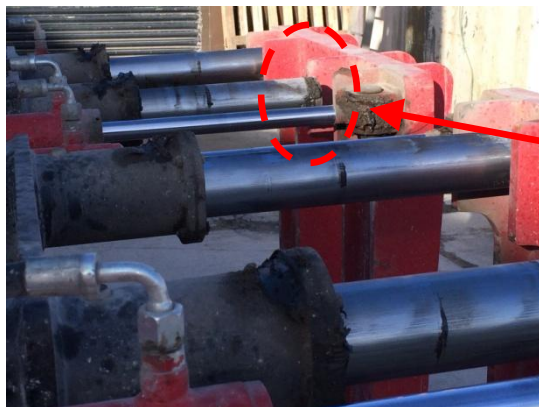
A clamp which was attached to a Linde HD 50 forklift failed catastrophically when a steel rod sheared. This resulted in a pack being dropped as it was being placed on the ground. The incident could have been much worse as packs can be stacked 4 to 5 cubes high at full extension. No injury occurred during the incident, but the potential was far greater.

Investigations identified that the clamp and truck had been in service just under three years and that the clamp attachment had been serviced within the last 9-10 months.

- The service of the clamp attachment and inspection routines failed to pick up this fault
- Existing clamp attachments should be checked / inspected by NDT to ensure they are crack free

- Amend service routine to cover NDT of area of rod that failed
- Review frequency of inspection and service
